DODGE Para-Flex: Element Inspection Criteria

C.O. Engineering - Bearings and PT Components
February 1, 2016

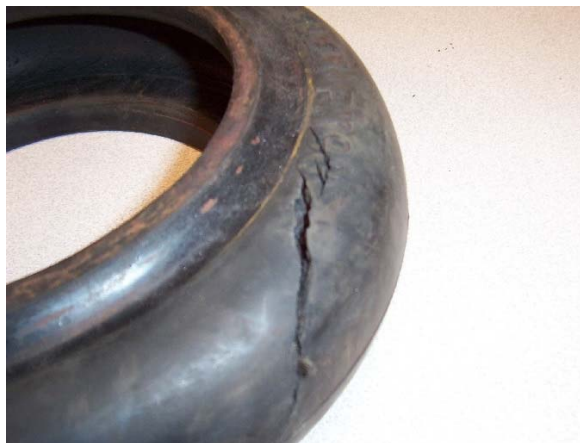
Figure 1 displays tearing consistent with overload or excessive torque. Overload and shock load conditions with rubber-based elements are evidenced with jagged wear patterns with the rubber. 45° tear propagation from the shaft centerline is also evidenced from the initial jagged tears. Overloads will often cause the element to slip between the hub and clamp ring, however, this condition is also representative of improper installation. If the tearing is severe, the element should be replaced at the time of the inspection.

Figure 1: Tearing Commonly Associated with Excessive Torque

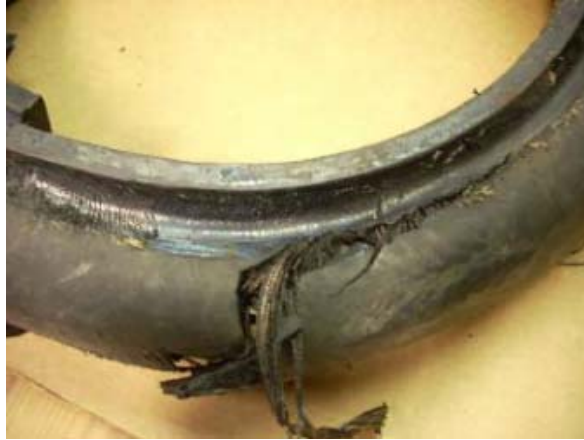
Fatigue in rubber-based elastomers is evidenced by cracks in the region of the element split. However, the primary fatigue damage is evidenced by large cracks located slightly above the clamp circle. These cracks extend completely through the element and often radially over the outside diameter of the element, as shown in Figure 2. As the cracks propagate, rubber debris, often similar to coffee grounds, will be evident beneath the coupling. Replacement is recommended when cracks extend for 20% or more of the element circumference. If the element is not replaced the cracks will continue to propagate and the reinforcement fabric will become torn and exposed. The fabric strands are often extended and bare.

Figure 2: Tearing Commonly Associated with Cyclic Stress

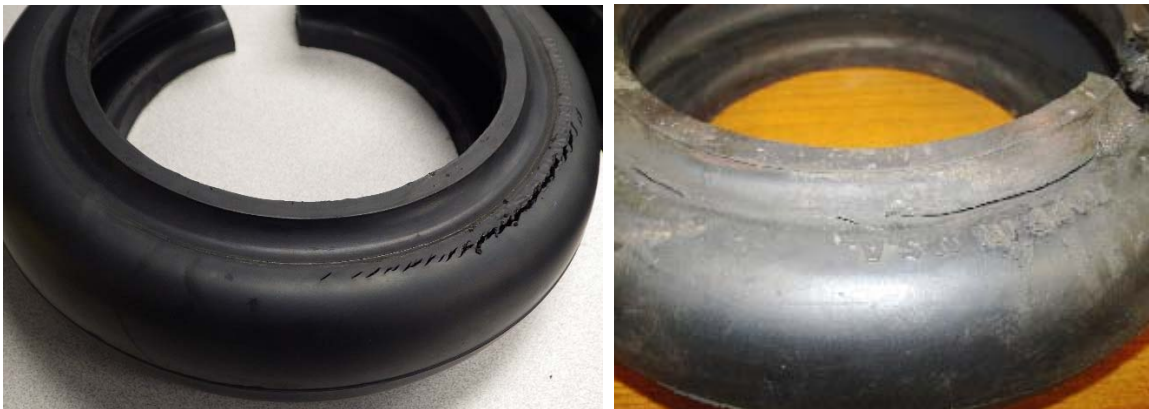
Though tearing radially over the diameter of the element show signs of fatigue failure, it can also be a sign of excessive parallel misalignment. Angular misalignment in rubber is usually represented by cracks above the clamp ring. These cracks and tears on the exterior sidewall that do not propagate angularly are indications of angular misalignment. Cracks on the interior surface of the element above the internal clamp ring are indicative of excessive end float.

Figure 3: Tearing Commonly Associated with Excessive Misalignment

If any tearing on the element is found during inspection, steps should be taken to determine the cause of failure in the system. Alignment of the connected equipment should be checked and corrected to minimize the effects of misalignment on the system. System requirements should also be checked and compared with the Para-Flex performance ratings to ensure that the proper size and service factor has been selected. Any sources of excessive vibration should also be isolated to maximize coupling life.

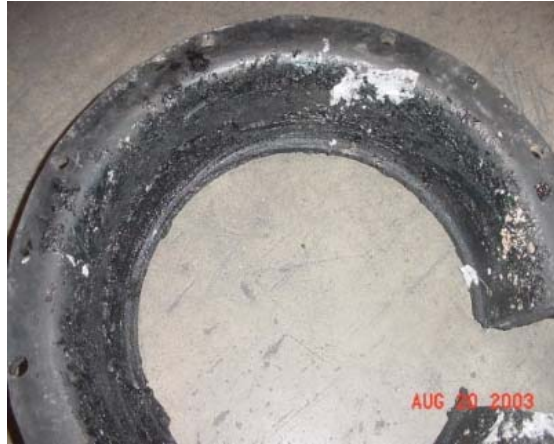
The DODGE Para-Flex coupling is designed to aid in vibration and shock load dampening. Misalignment can occur over time as foundations settle which in turn can cause vibration. This vibration causes excess energy that is absorbed by the rubber element causing an internal buildup of heat. This phenomenon is known as hysteresis. As long as the heat is dissipated, the elastomeric couplings can handle high levels of misalignment. When the effects of vibration are high enough, the rubber will begin to revert to its natural rubber properties prior to vulcanization. Signs of soft or tacky rubber will be apparent. If severe, plans should be made to replace the element immediately.

Figure 3: Degradation of Rubber Due to Excessive Vibration
