WP0164

Dodge® Para-Flex couplings: element inspection criteria

Dodge Customer/Order Engineering

02-01-2016

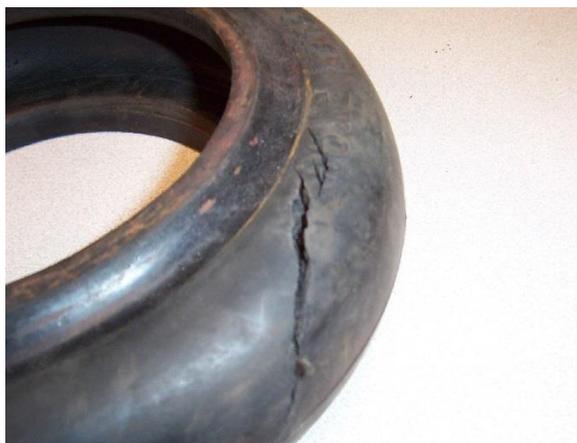
Figures 1 displays tearing consistent with overload or excessive torque. Overload and shock load conditions with rubber-based elements are evidenced with jagged wear patterns with the rubber. 45° tear propagation from the shaft centerline is also evidenced from the initial jagged tears. Overloads will often cause the element to slip between the hub and clamp ring, however, this condition is also representative of improper installation. If the tearing is severe, the element should be replaced at the time of the inspection.

Figure 1. Tearing Commonly Associated with Excessive Torque

If any tearing on the element is found during inspection, steps should be taken to determine the cause of failure in the system. Alignment of the connected equipment should be checked and corrected to minimize the effects of misalignment on the system. System requirements should also be checked and compared with the Para-Flex performance ratings to ensure that the proper size and service factor has been selected. Any sources of excessive vibration should also be isolated to maximize coupling life.

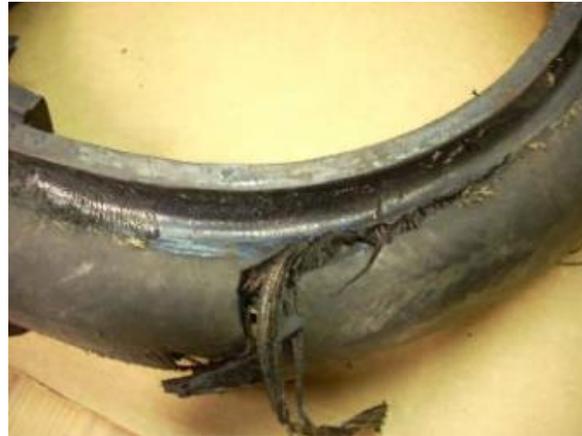
Fatigue in rubber-based elastomers is evidenced by cracks in the region of the element split. However, the primary fatigue damage is evidenced by large cracks located slightly above the clamp circle. These cracks extend completely through the element and often radially over the outside diameter of the element, as shown in **Figure 2**. As the cracks propagate, rubber debris, often similar to coffee grounds, will be evident beneath the coupling. Replacement is recommended when cracks extend for 20% or more of the element circumference. If the element is not replaced the cracks will continue to propagate and the reinforcement fabric will become torn and exposed. The fabric strands are often extended and bare.

Figure 2. Tearing Commonly Associated with Cyclic Stress

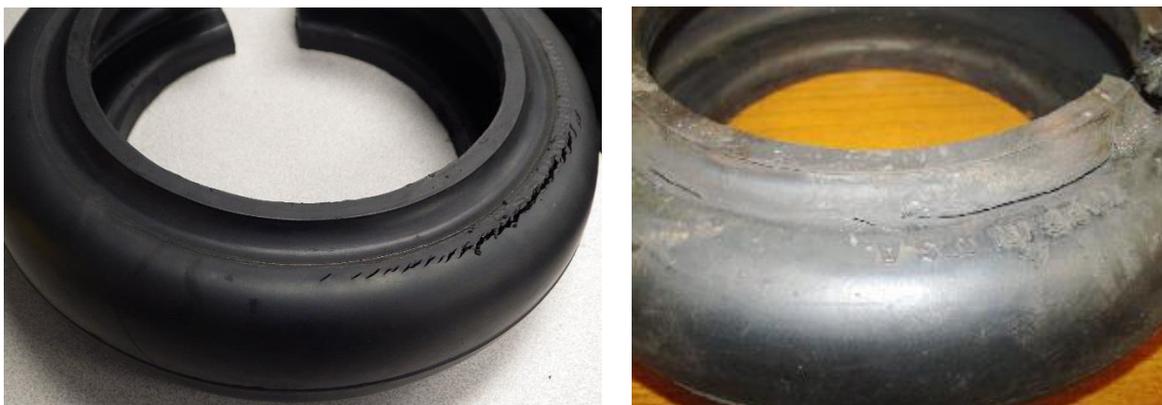
Though tearing radially over the diameter of the element show signs of fatigue failure, it can also be a sign of excessive parallel misalignment. Angular misalignment in rubber is usually represented by cracks above the clamp ring. These cracks and tears on the exterior sidewall that do not propagate angularly are indications of angular misalignment. Cracks on the interior surface of the element above the internal clamp ring are indicative of excessive end float.

Figure 3. Tearing Commonly Associated with Excessive Misalignment

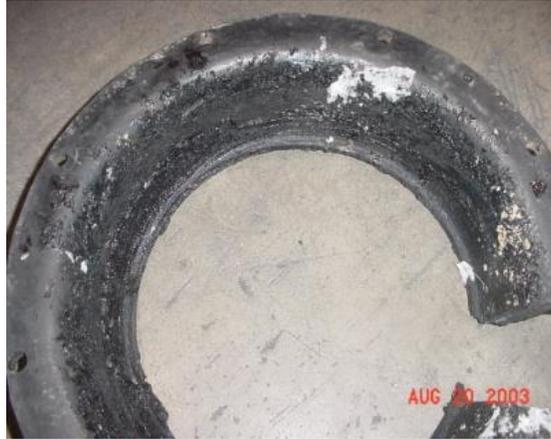
The Dodge Para-Flex coupling is designed to aid in vibration and shock load dampening. Misalignment can occur over time as foundations settle which in turn can cause vibration. This vibration causes excess energy that is absorbed by the rubber element causing an internal buildup of heat. This phenomenon is known as hysteresis. As long as the heat is dissipated, the elastomeric couplings can handle high levels of misalignment. When the effects of vibration are high enough, the rubber will begin to revert to its natural rubber properties prior to vulcanization. Signs of soft or tacky rubber will be apparent. If severe, plans should be made to replace the element immediately.

Figure 3. Degradation of Rubber Due to Excessive Vibration
