WP0203

Dodge® mounted bearings: frosty raceway failure analysis

Dodge Customer/Order Engineering

04-15-2015

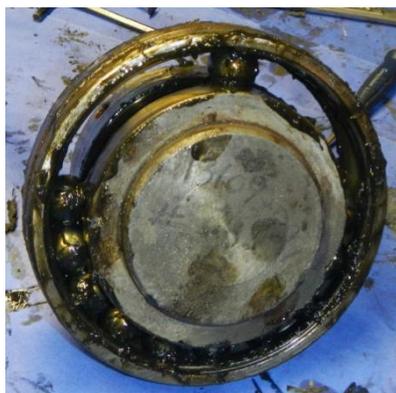
Figure 2. Subject bearing

Upon teardown and inspection of the bearing, significant contamination was found beneath the rubberized flinger and within the bearing cavity. Proper re-lubrication would have prevented this by forcing contaminants out before they could reach the bearing cavity. The grease had turned from light green to almost black, indicating the lubrication had begun to breakdown. Bearings rely on proper lubrication to reduce friction and prevent metal to metal contact. As the grease begins to breakdown, its lubricating properties diminish and the probability of metal to metal contact increases. Again, proper re-lubrication would have supplied fresh grease and maintained adequate lubricity.

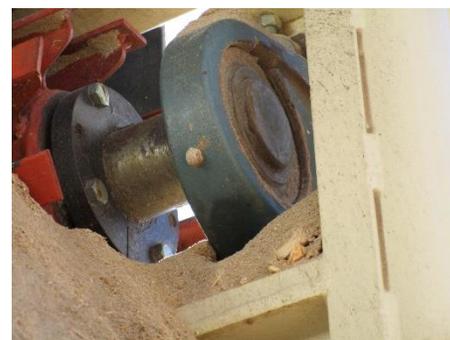
Figure 1. Subject bearing in

To investigate, we will look at a ball bearing pulled from service after approximately one year. This bearing supported a take-up pulley on a conveyor which transports wood material at a biofuel energy plant. The conveyed material ranged in size from softball sized chunks to fine sawdust. Poor maintenance

practices allowed the sawdust to become compacted around the bearings. Further evidence showed the bearings had not been properly re-lubricated.

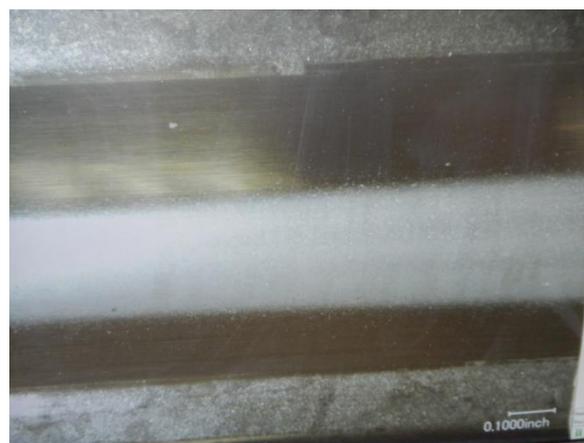
Once the bearing was completely disassembled and the components cleaned, the inner and outer ring raceways were inspected. While the majority of the raceway surfaces appeared shiny and new, a dull track was evident around the entire circumference of both the inner and outer ring raceways. This dull track, shown in **Figure 3**, is what we refer to as a frosty raceway.

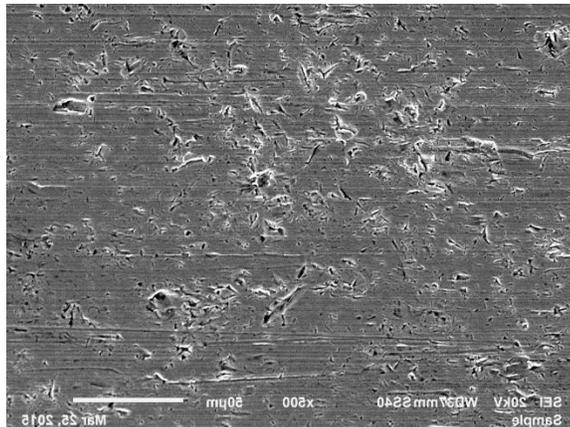
Figure 5. Frosty area of the outer ring

The straight circumferential lines are score marks left by the honing operation during manufacturing and are what you would expect to see on a new bearing. Now let's look at the dull, or frosty, area of the outer ring. **Figure 5** shows this area as seen under the same 500 times magnification. Here, nearly gone are the score marks from the grinding operation. Instead, the area is covered with microscopic dents and pits.

Now that we know what frosty raceways look like, what causes them and why should we care? Like our subject bearing exposed to fine sawdust, a bearing that is not properly sealed or re-lubricated can become contaminated. As contamination works its way into the bearing cavity, it becomes trapped in the grease. Ultimately, these particles can get between the rollers and raceways and act as a lapping compound, creating the wear damage seen in **Figure 5**. This wear is what gives the raceway a dull, or frosty, appearance in the ball track.

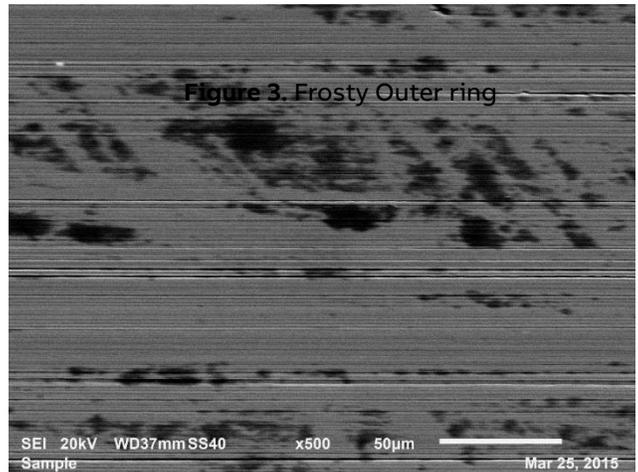
Figure 4. Shiny area of the outer ring at 500x magnification

To get a better feel for what is going on, let us take a look at the raceway under a scanning electron microscope. **Figure 4** shows the shiny area of the outer ring at 500 times magnification
