WP0157

Dodge® Raptor couplings: element inspection criteria

Dodge Customer/Order Engineering

10-22-2015

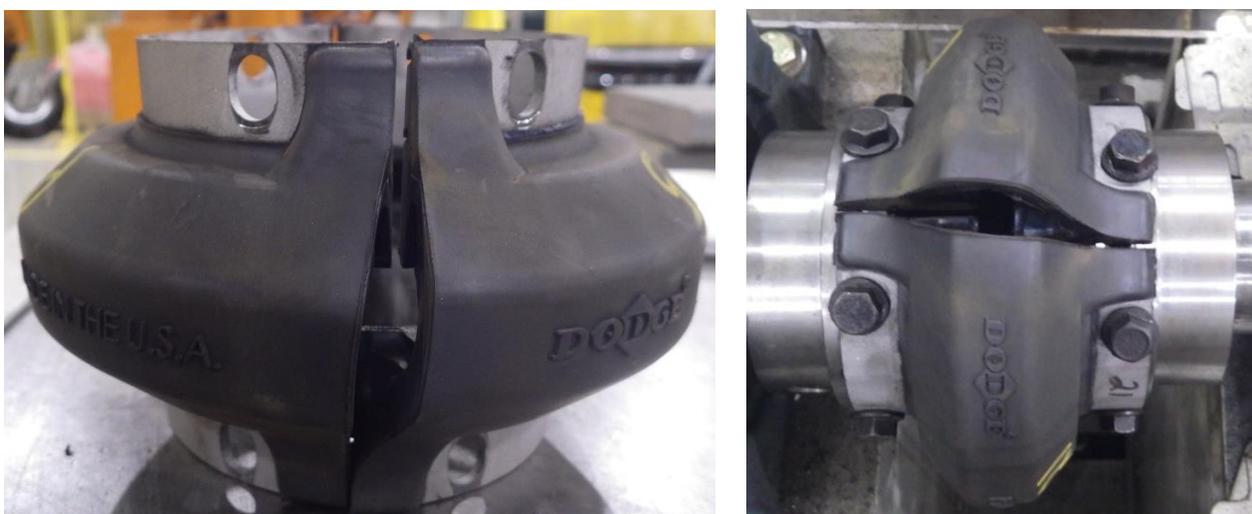
The Dodge Raptor's natural rubber elements are designed with a 50% lower torsional and bending stiffness. Lower torsional and bending stiffness reduces bearing loads, lowers vibration, and dampens shock loading. Raptor elements that have run for two years may begin to see minor levels of element creep at the element split. Creep is defined as the progressive wind-up of an elastomer. Wind-up is the amount of angular displacement achieved when torque is applied to a coupling. This creep is normal and is a result of the low torsional and bending stiffness of the natural rubber element. **Figure 1** depicts Raptor elements with standard creep patterns. These elements are still well within their useful life and do not need to be replaced at this time.

Figure 1. Dodge Raptor standard creep patterns.

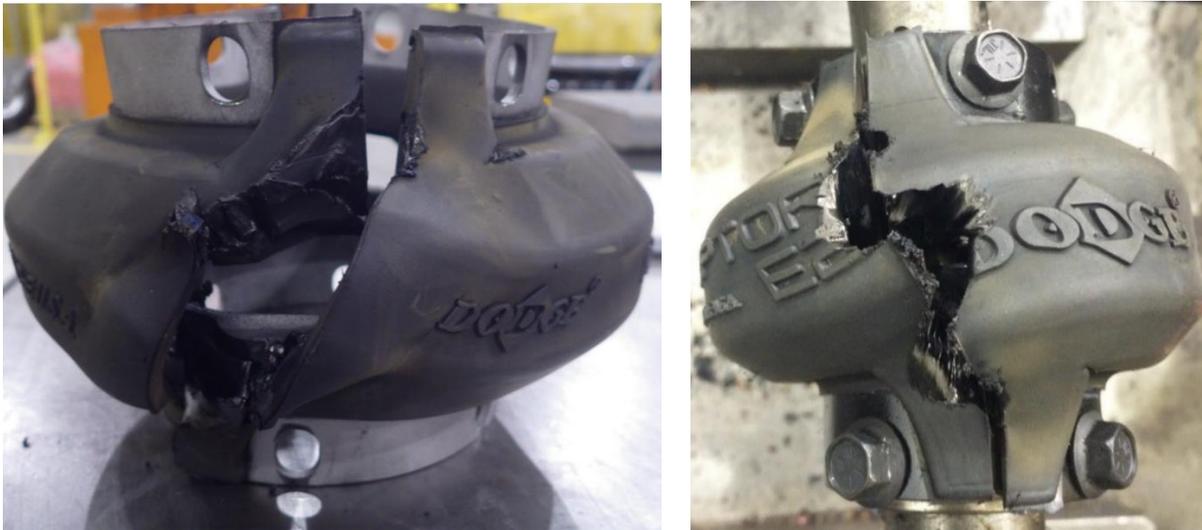
Over time foundations settle, vibration occurs, and some level of misalignment typically occurs. When elastomeric couplings are misaligned, energy is created in the form of heat, in a phenomena known as hysteresis. As long as this heat is dissipated properly, the elastomeric couplings can handle high levels of misalignment. However, if misalignment is severe and exceeds acceptable limits, then the combined effect can result in poor performance and premature failure. The same is true as a result from high application torque and vibration.

Initial signs of this break down from excessive misalignment, high application torque, or excessive vibration can be seen in the form of tearing or deterioration of the Dodge Raptor's natural rubber element at the split between the two element halves. **Figures 2 and 3** depict different forms of tearing or deterioration at the element split. If any of these wear patterns are seen on your Raptor element, plans should be made to replace it at the next scheduled down time. If the tearing is severe, the element should be replaced at the time of the inspection.

Figure 2. Typical tearing patterns at the element split as a result of excessive misalignment, torque, or vibration.

If tearing at the element split, tearing of the element wings, or separation of the wings is found during element inspection, steps should be taken to determine the cause of failure in the system. Alignment of the connected equipment should be checked and corrected to minimize the effects of misalignment on the system. System requirements should also be checked and compared with the Raptor performance ratings to ensure that the proper size and service factor has been selected. Any sources of excessive vibration should also be isolated to maximize coupling life.

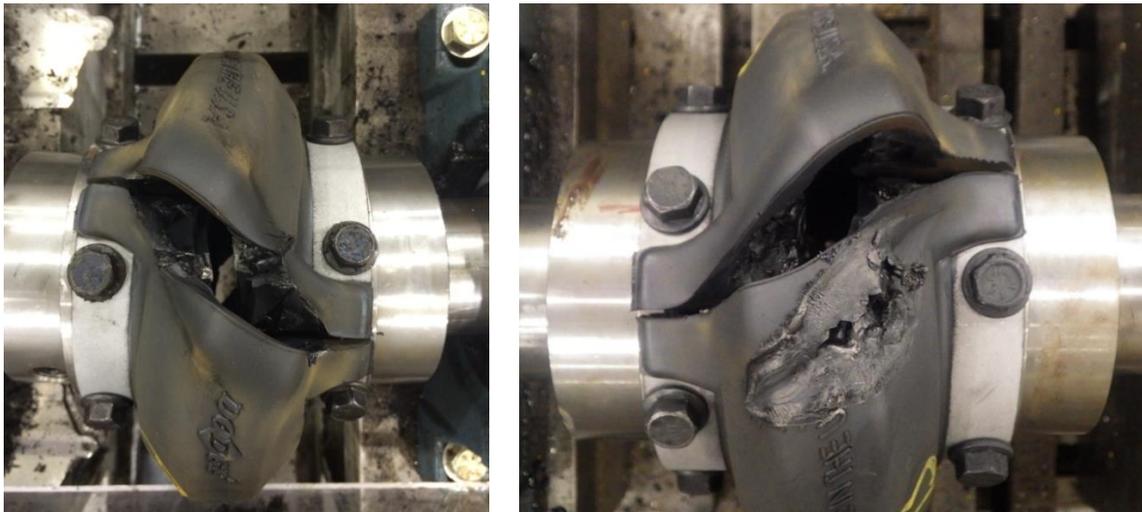
Figure 3. Typical tearing patterns at the element split as a result of excessive misalignment, torque, or vibration.

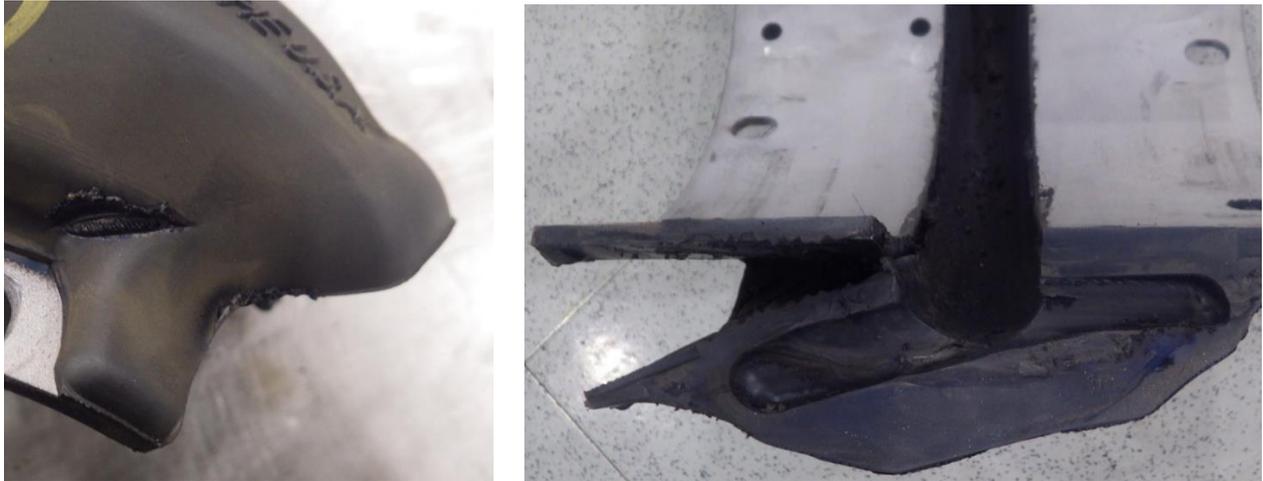
Every application presents its own challenges for elastomeric couplings. High levels of vibration, torque spikes, excessive misalignment, and other similar events can decrease the life of your Dodge Raptor's natural rubber element. During the inspection of the element, it is good practice to look for tearing or separation of the Raptor element's

wings. **Figure 4** shows examples of the type of tearing you may experience. If tearing or separation of the wings is detected on your Raptor element, plans should be made to replace it at the next scheduled down time. If the tearing is severe, the element should be replaced at the time of the inspection.

Figure 4. Typical tearing patterns at the element split as a result of excessive misalignment, torque, or vibration.
