DODGE RAPTOR: Element Inspection Criteria

C.O. Engineering - Bearings and PT Components
October 22, 2015

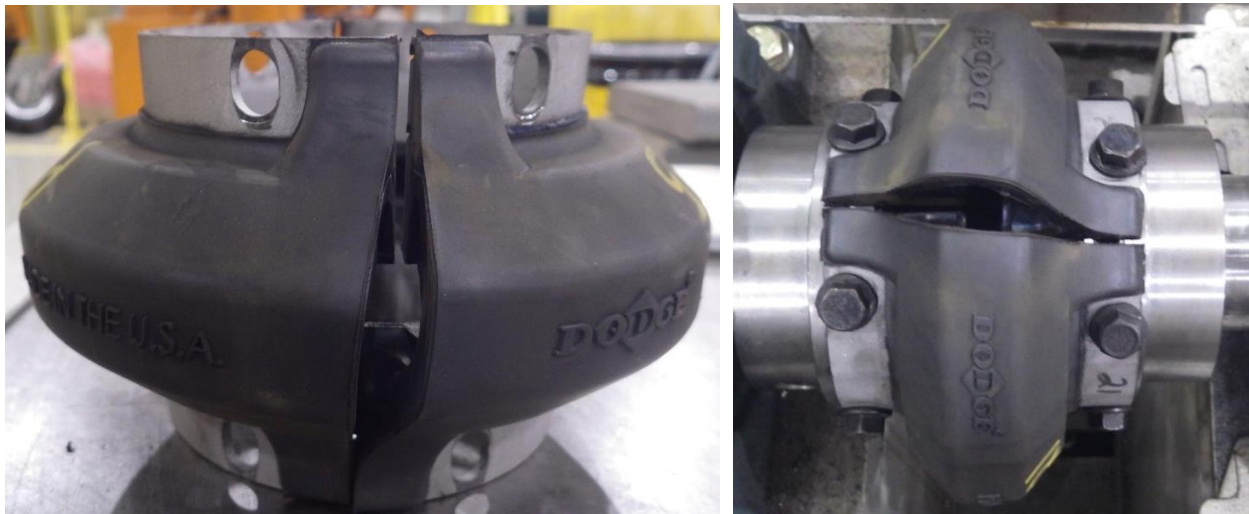
The DODGE RAPTOR's natural rubber elements are designed with a 50% lower torsional and bending stiffness. Lower torsional and bending stiffness reduces bearing loads, lowers vibration, and dampens shock loading. RAPTOR elements that have run for two years may begin to see minor levels of element creep at the element split. Creep is defined as the progressive wind-up of an elastomer. Wind-up is the amount of angular displacement achieved when torque is applied to a coupling. This creep is normal and is a result of the low torsional and bending stiffness of the natural rubber element. Figure 1 depicts RAPTOR elements with standard creep patterns. These elements are still well within their useful life and do not need to be replaced at this time.

Figure 1: DODGE RAPTOR standard creep patterns.

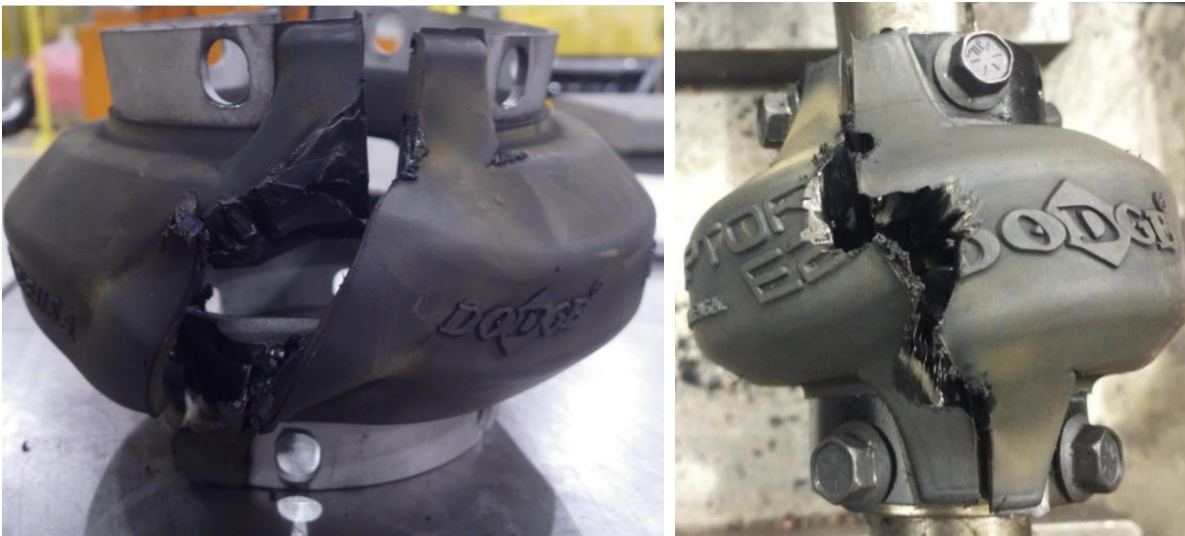
Initial signs of this break down from excessive misalignment, high application torque, or excessive vibration can be seen in the form of tearing or deterioration of the DODGE RAPTOR's natural rubber element at the split between the two element halves. Figures 2 and 3 depict different forms of tearing or deterioration at the element split. If any of these wear patterns are seen on your RAPTOR element, plans should be made to replace it at the next scheduled down time. If the tearing is severe, the element should be replaced at the time of the inspection.

Figure 2: Typical tearing patterns at the element split as a result of excessive misalignment, torque, or vibration.

If tearing at the element split, tearing of the element wings, or separation of the wings is found during element inspection, steps should be taken to determine the cause of failure in the system. Alignment of the connected equipment should be checked and corrected to minimize the effects of misalignment on the system. System requirements should also be checked and compared with the RAPTOR performance ratings to ensure that the proper size and service factor has been selected. Any sources of excessive vibration should also be isolated to maximize coupling life.

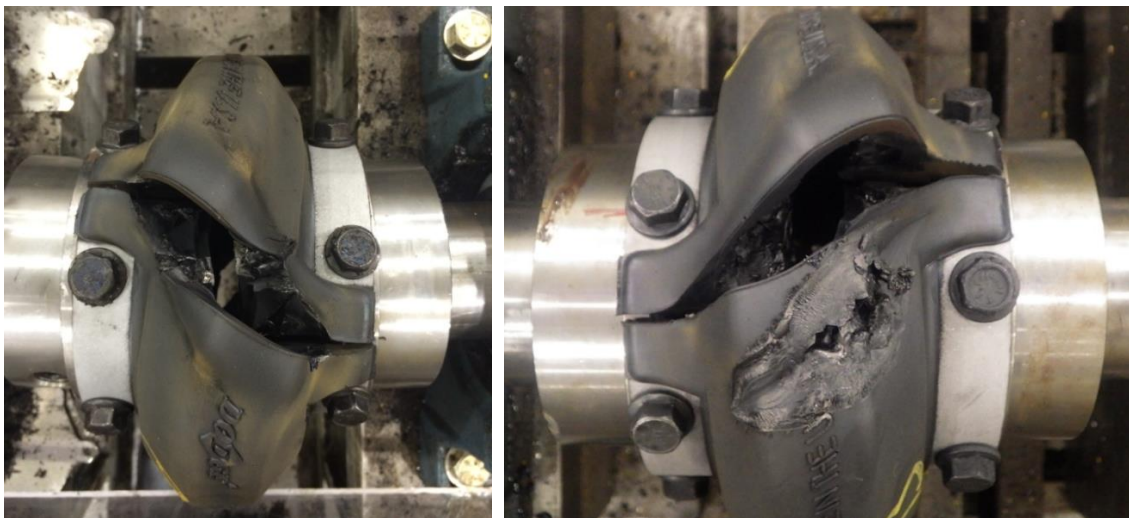
Figure 3: Typical tearing patterns at the element split as a result of excessive misalignment, torque, or vibration.

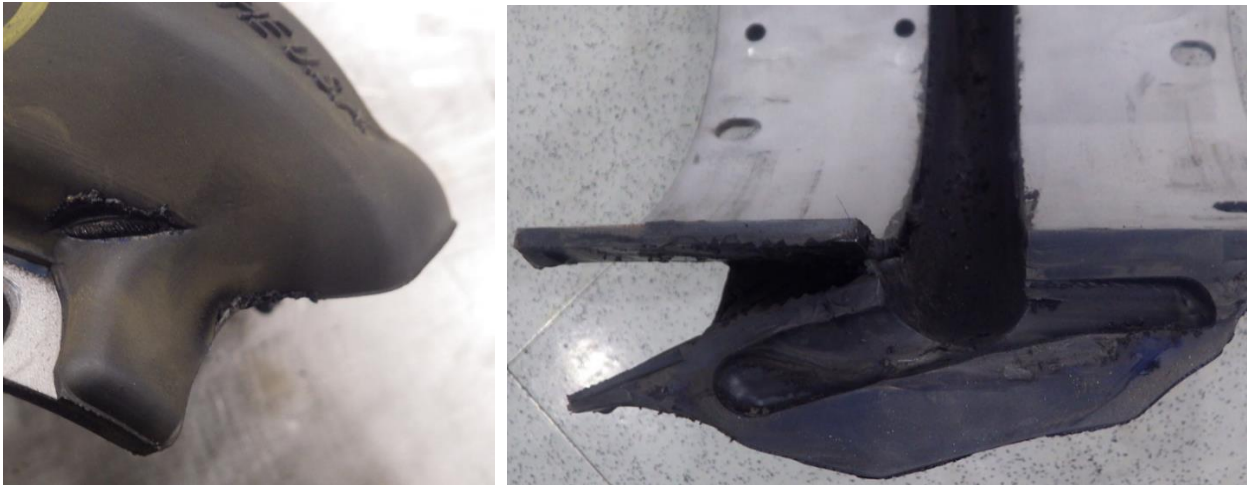
Every application presents its own challenges for elastomeric couplings. High levels of vibration, torque spikes, excessive misalignment, and other similar events can decrease the life of your DODGE RAPTOR's natural rubber element. During the inspection of the element, it is good practice to look for tearing or separation of the RAPTOR element's wings. Figure 4 shows examples of the type of tearing you may experience. If tearing or separation of the wings is detected on your RAPTOR element, plans should be made to replace it at the next scheduled down time. If the tearing is severe, the element should be replaced at the time of the inspection.

Figure 4: Typical tearing patterns at the element split as a result of excessive misalignment, torque, or vibration.
