## **DODGE Para-Flex: Element Inspection Criteria**

C.O. Engineering - Bearings and PT Components  
February 1, 2016

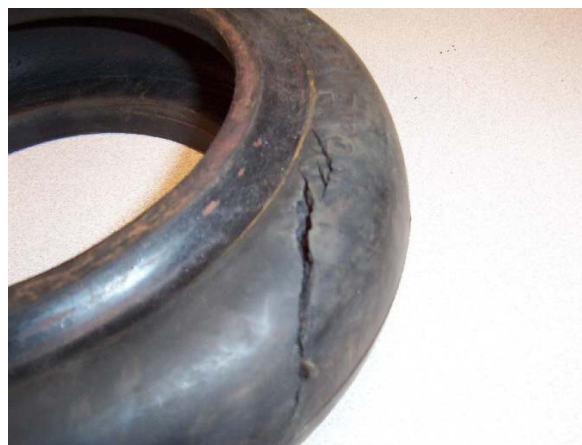
Figure 1 displays tearing consistent with overload or excessive torque. Overload and shock load conditions with rubber-based elements are evidenced with jagged wear patterns with the rubber. 45° tear propagation from the shaft centerline is also evidenced from the initial jagged tears. Overloads will often cause the element to slip between the hub and clamp ring, however, this condition is also representative of improper installation. If the tearing is severe, the element should be replaced at the time of the inspection.

**Figure 1: Tearing Commonly Associated with Excessive Torque**

If any tearing on the element is found during inspection, steps should be taken to determine the cause of failure in the system. Alignment of the connected equipment should be checked and corrected to minimize the effects of misalignment on the system. System requirements should also be checked and compared with the Para-Flex performance ratings to ensure that the proper size and service factor has been selected. Any sources of excessive vibration should also be isolated to maximize coupling life.

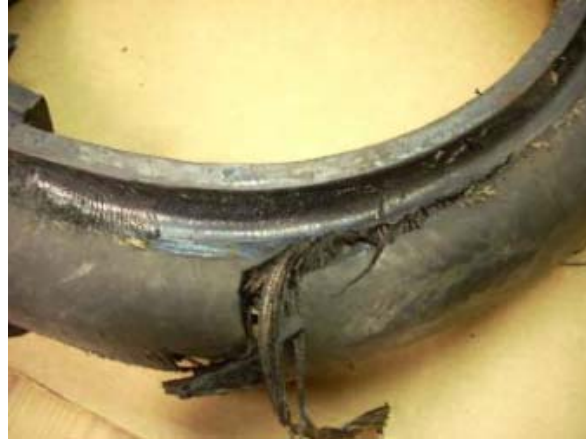
Fatigue in rubber-based elastomers is evidenced by cracks in the region of the element split. However, the primary fatigue damage is evidenced by large cracks located slightly above the clamp circle. These cracks extend completely through the element and often radially over the outside diameter of the element, as shown in Figure 2. As the cracks propagate, rubber debris, often similar to coffee grounds, will be evident beneath the coupling. Replacement is recommended when cracks extend for 20% or more of the element circumference. If the element is not replaced the cracks will continue to propagate and the reinforcement fabric will become torn and exposed. The fabric strands are often extended and bare.

**Figure 2: Tearing Commonly Associated with Cyclic Stress**
